Required Troubleshooting Procedure to Return Healy 900 Series Nozzles for Warranty Replacement

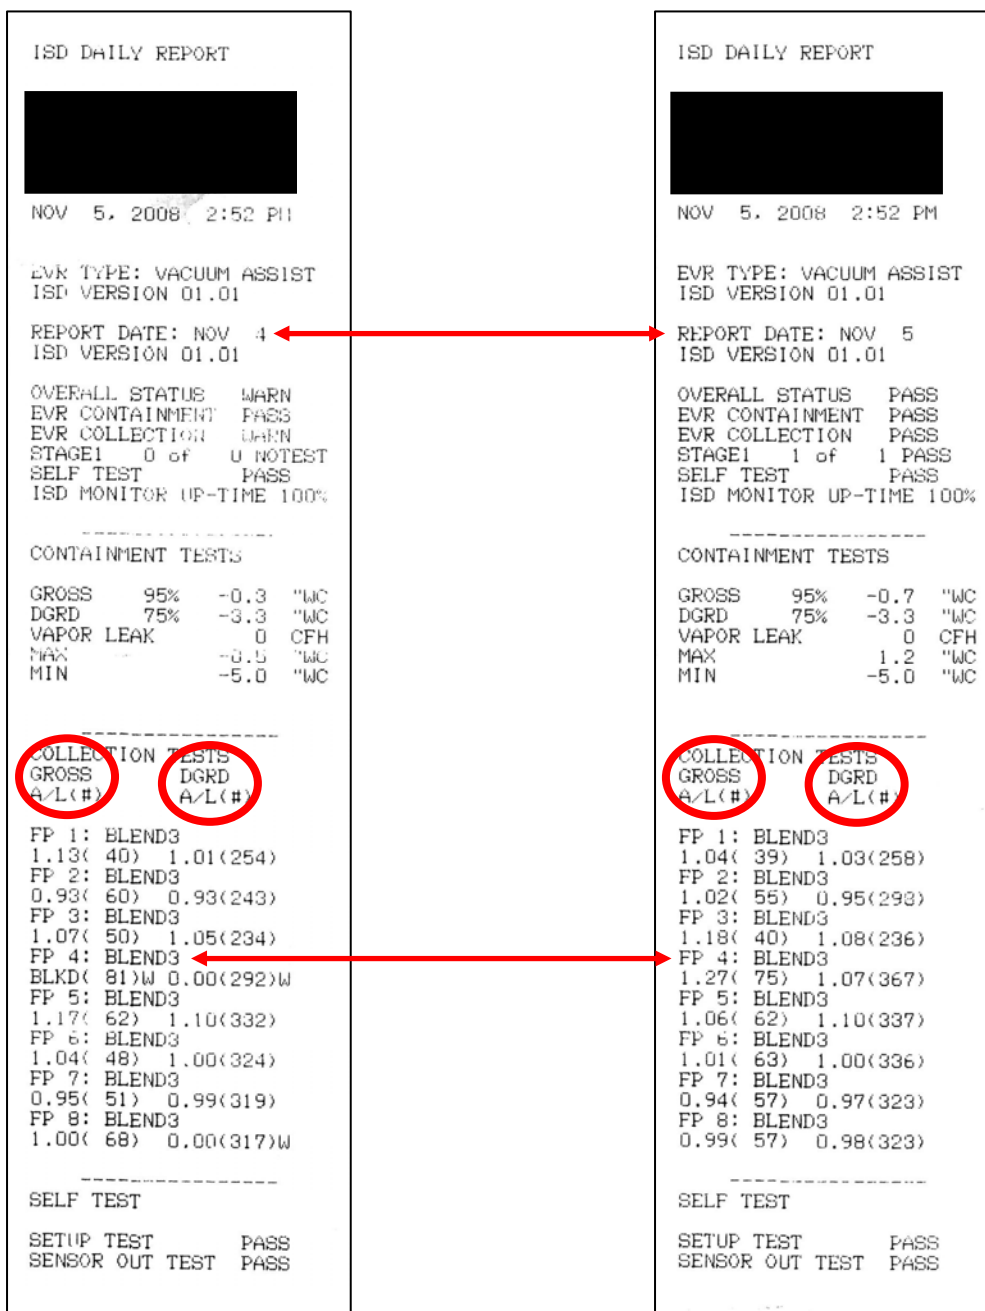
- a. Gross Collection Warning/Alarm criteria is <0.33 or >1.90
 - b. Degradation Collection Warning/Alarm is <0.81 or >1.32
 - i. NOTE: A value of 'BLKD' in the Gross (daily) section, coupled by a '0.00' in the 'DGRD' (weekly) section for a fueling point may not mean that there is a true blockage. It could instead mean there was a statistical anomaly that occurred: specifically, the number of ORVR cars exceeded the expected value for that day. If the fueling point in question has normal V/L values for other days, it confirms there is not a problem with the vapor recovery system (see Figure 1, FP4 for an example). The following are further steps required to confirm system operation.

Figure 1
See FP 4 on two consecutive days (Nov 4 & 5) for an example of a statistical BLKD anomaly. The warning cleared on Nov. 5. The system is operating normally.
