TS-DTU Noise Suppression Cables

TS-DRK

Installation Guide

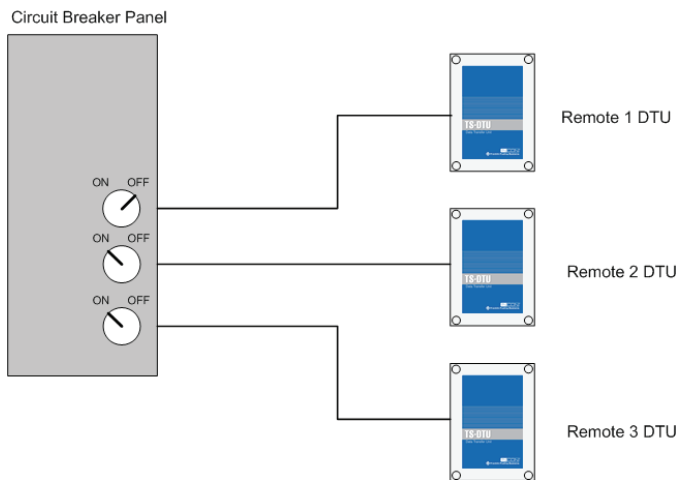
Figure 1: Example of Dispenser 1 (Remote 1 DTU) Shutdown

1. Dispenser is powered down. A Remote DTU is powered from the dispenser power. If the dispenser was powered down for any reason it will result in a “Remote DTU is Offline” alarm. See Figure 1.

1. Multiple “Remote DTU is offline” alarms occur at the same time (Refer to Figure 1).

By noting the time all the Remote DTUs went offline, it is clear that these were caused by some power loss either manually or the console shutdown the dispensers (Figure 5).

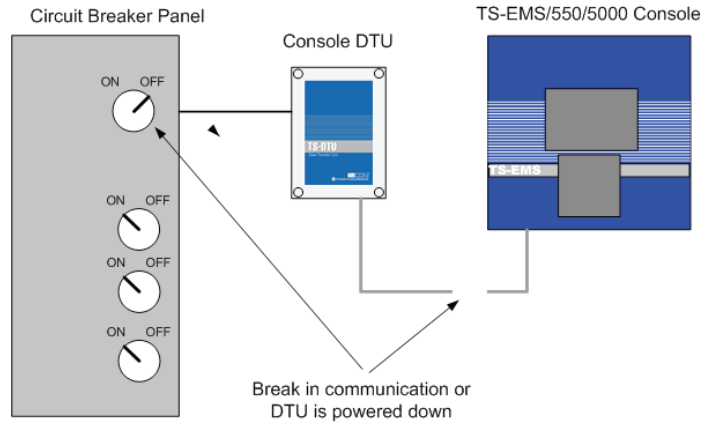
Figure 2 - Console DTU powered down or lost communication

2. Console DTU is powered down or disconnected from the Console. The Console DTU transfers the Remote DTU data to the console. If this Console DTU loses communication either due to being powered down or disconnects from the bus, then all the Remote DTUs will issue the “Remote DTU is Offline” alarm. In conjunction, you should also see a “Console DTU Module Mismatch” alarm. See Figure 2

2. ISD alarm 1 to 2 minutes before the “Remote DTU is offline” alarm occurs. (Refer to Figure 2).

The result of an ISD Vapor Collection Failure alarm is that the console shuts off power to the dispenser. In Figure 2, Dispenser 3 generated an VRM Failure alarm for both its fueling point and shutdown the dispenser. A minute and half later, “Remote DTU is offline” alarm was generated because the DTU did not have power.

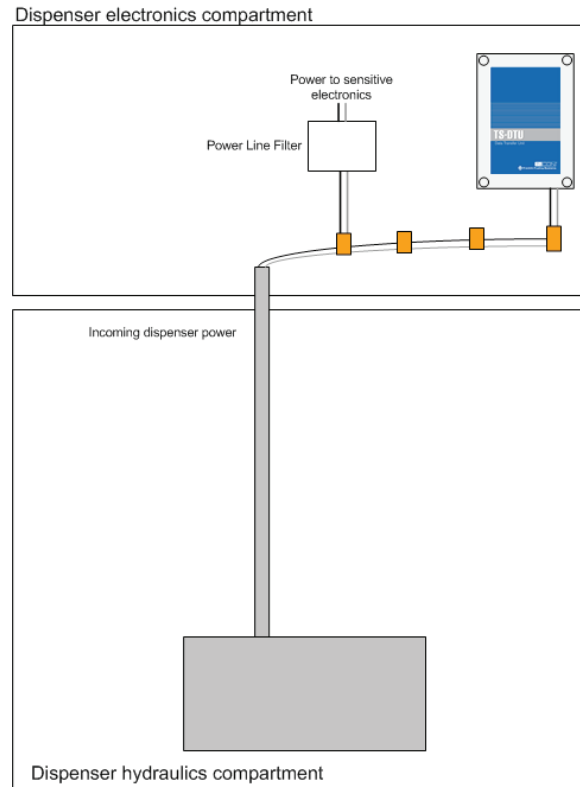
Figure 3 - Power Line Filter loading DTU signal

3. Remote signal strength is not strong enough. If the Remote DTU signal has been attenuated (loses strength) then the Console DTU may not be able to reliably read the incoming data. This is a common issue when there are power line filters installed inside the dispenser as they try and filter the signals as if it was noise. See Figure 3.

A new Noise Reduction DTU cable may need to be installed if there seems to be low DTU Quality problems. This cable consist of two ferrites (magnetic rings) that isolate loading issues from either power line filters or switching power supplies. This cable is to be installed at the incoming power connection so it isolates all the electronics in the dispenser.

Note: Take special notice that the power to the DTU does not go through the ferrites, it should branch before the ferrites.
